A SECURE TECHNOLOGY ALLIANCE ACCESS CONTROL COUNCIL WHITE PAPER

# TWIC<sup>®</sup> Card/Reader Use with Physical Access Control Systems: A Field Troubleshooting Guide

A Guide to Effective Diagnosis and Correction of TWIC® Card/Reader Field Issues

Version 1.0 May 2018

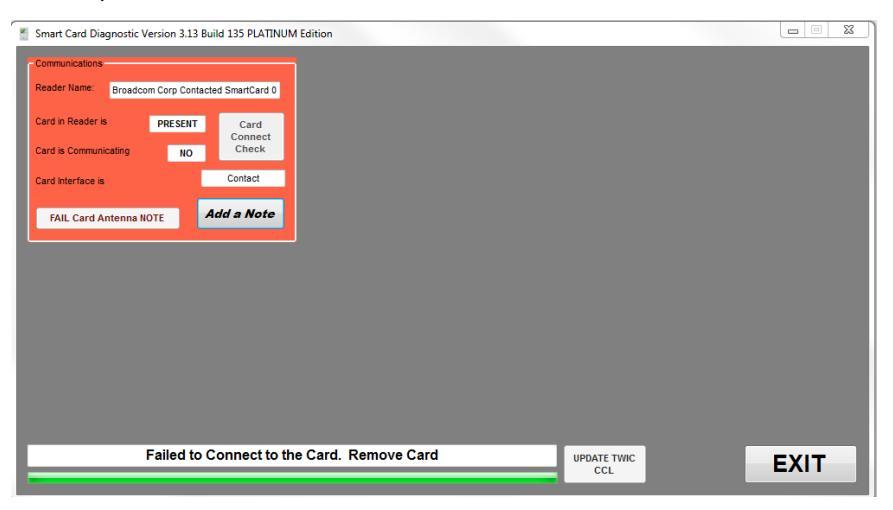
Figure 5. Resulting Screen Shot When an Unresponsive Card Is Presented

Figure 5 shows the message given by the utility when the card presented on a contact reader does not work (unresponsive card).
