***PIV Card/Reader Challenges with Physical  
Access Control Systems: A Field  
Troubleshooting Guide***

*A Guide to Effective Diagnosis and Correction of PIV Card/Reader Field  
Issues*

*A Smart Card Alliance Access Control Council and Identity Council White  
Paper*

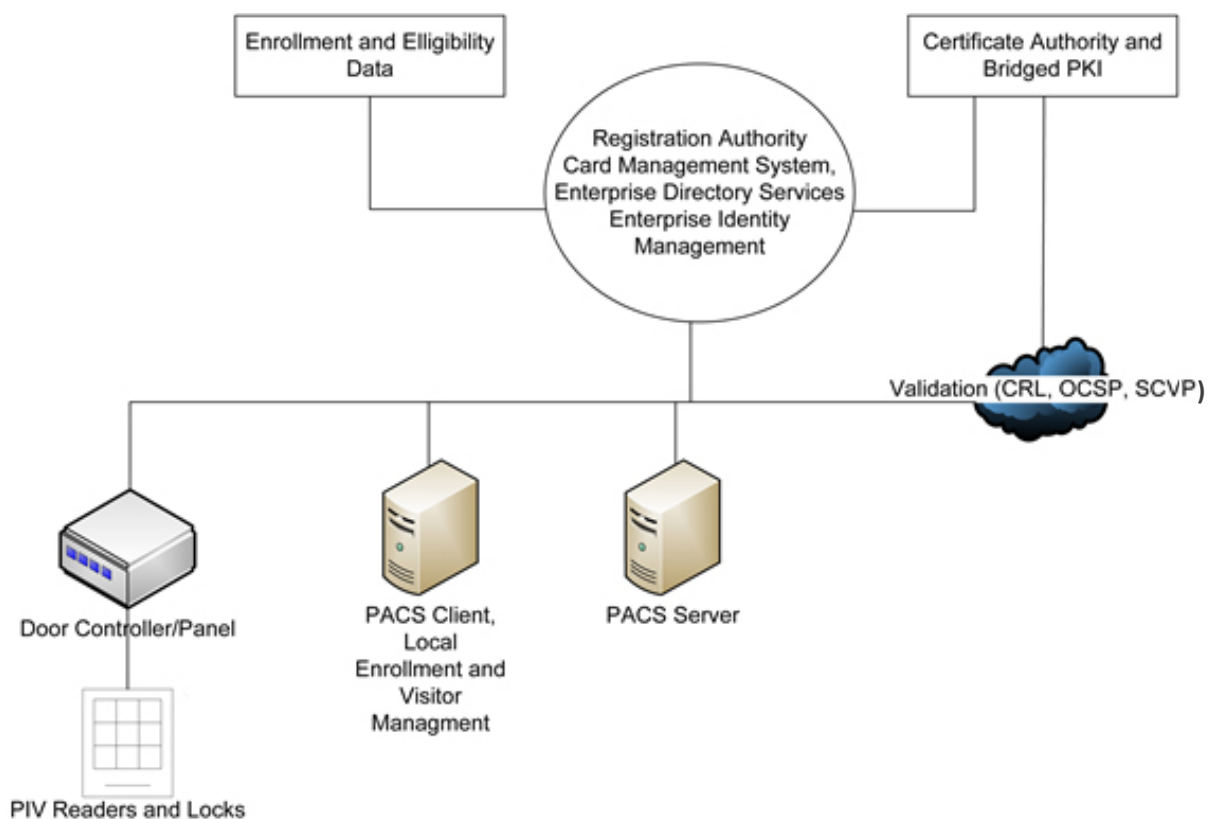
Figure 1 shows an example of a basic agency test lab configuration.

**Figure 1. Example of Basic Agency Test Lab Configuration**

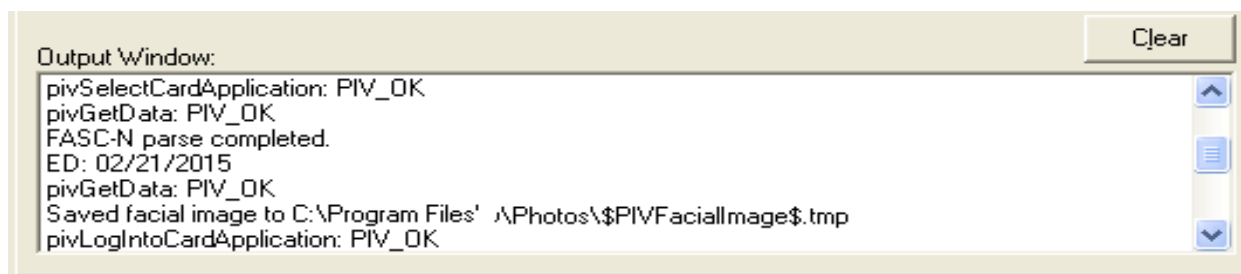
**Figure 2. Successful Read of PIV Card**

Level two tests require some basic skills and the ability to use simple diagnostic tools. Diagnostic tools are now commercially available. Contact the PACS manufacturer, card manufacturer, or systems integrator/installer for information about available diagnostic tools. Diagnostic tools will typically display the card data that is read by a reader and transmitted to a display for viewing. Card data that is displayed may include the card version, expiration date, and other data objects.<sup>7</sup> Figure 2 shows a generic example of a diagnostic viewer displaying a successful card read.

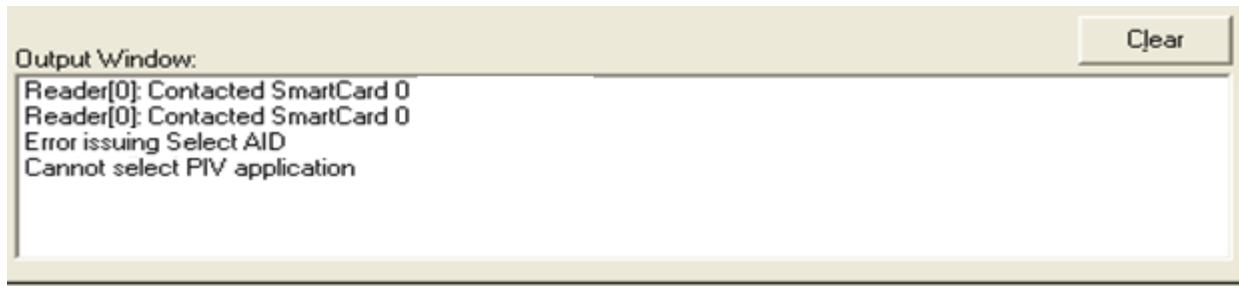
Figure 3 shows a generic example of an unsuccessful attempt to read the card.

**Figure 3. Unsuccessful Attempt to Read the PIV Card - AID Error**
